**ENVIRONMENTAL COMPLIANCE  
ASSESSMENT OF  
TULLY LAKE  
ROYALSTON, MASSACHUSETTS**

**PRELIMINARY FINDINGS REPORT  
U.S.Army Corps of Engineers  
New England Division**

SUBJECT: Environmental Compliance Assessment of Tully Lake

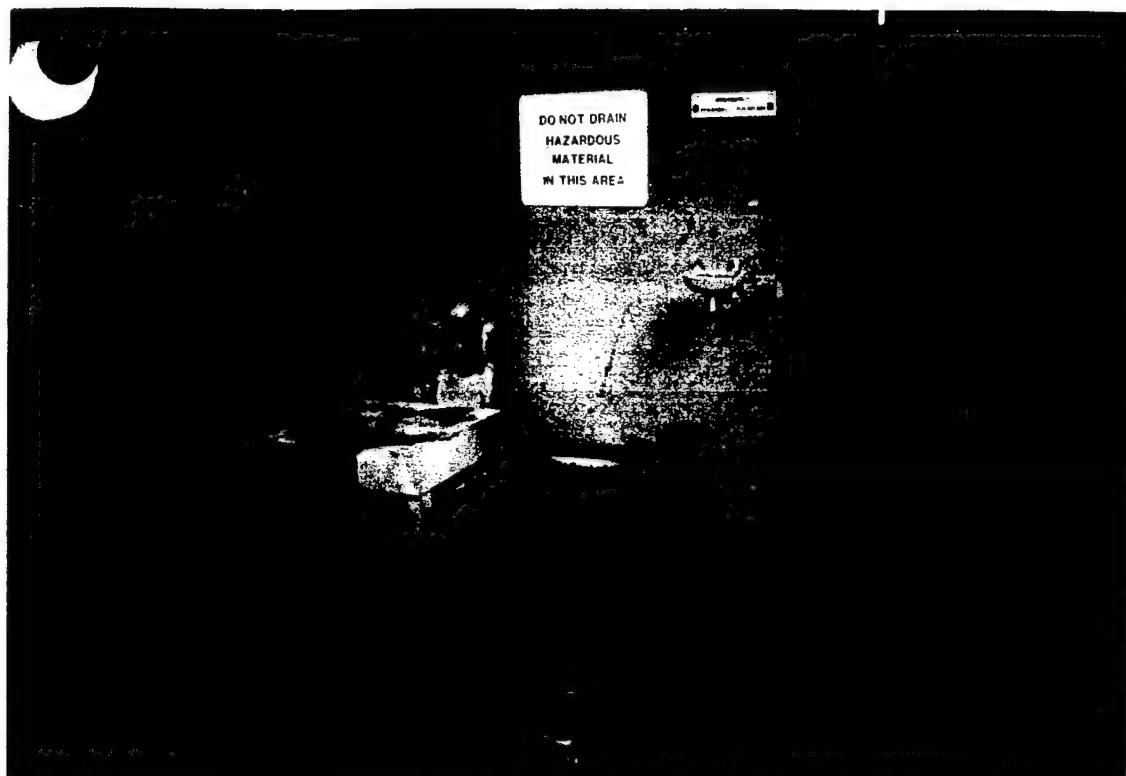
Photograph 3

**Maint. & Paint Shop**

- 1. Violation of CWA**
- 2. Requires NPDES permit**
- 3. Discharge of Hazardous waste into reported storm drain**

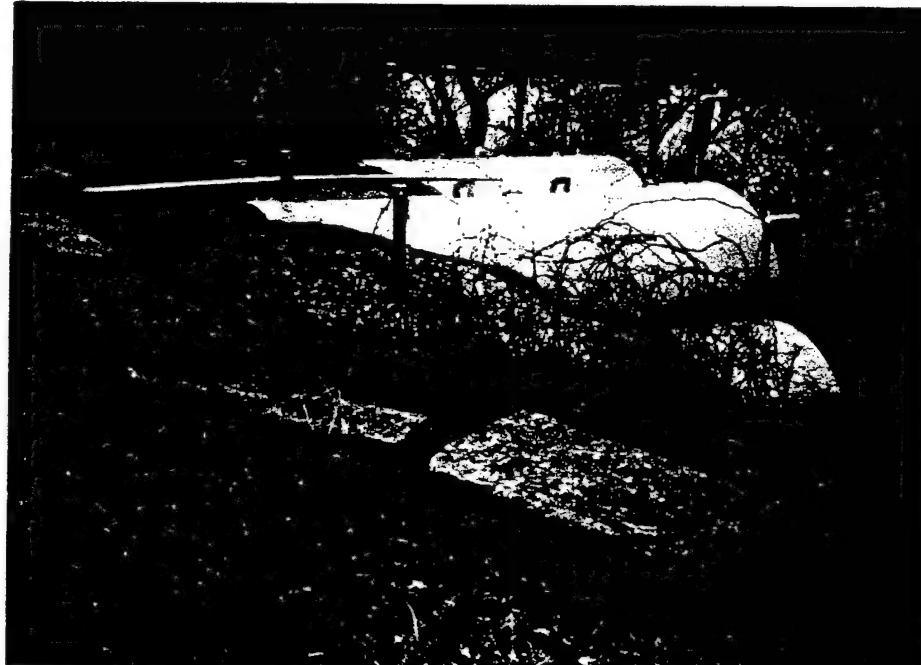
Photograph 14

Storage/Wash and  
Fuel Transfer  
Site

1. Violation of RCRA and CERCLA
2. Soil contamination
3. Requires spill contingency plan
4. Improper storage of hazardous materials
5. Housekeeping

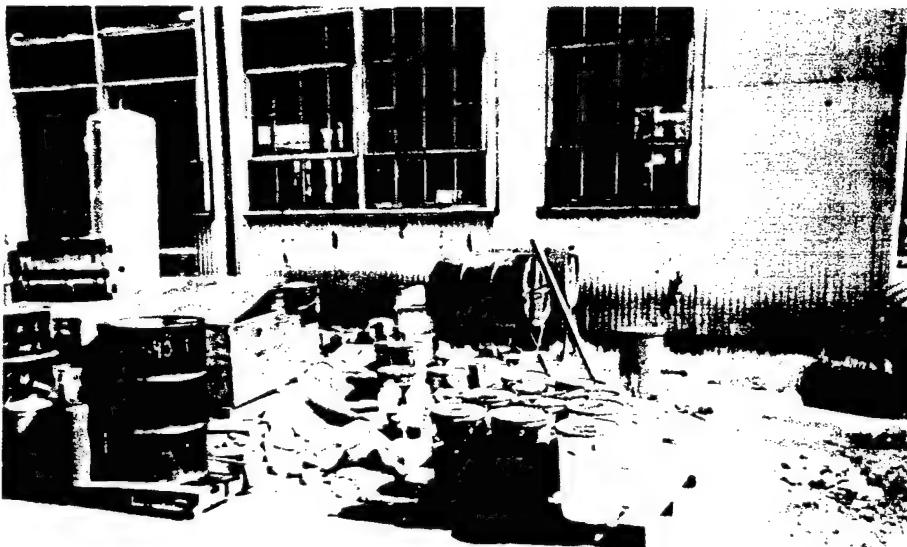
Photograph 18

Oil Rights  
Outgrant

1. Violation of RCRA, CWA
2. Soil Contamination
3. Lease enforcement
4. Spill contingency plan

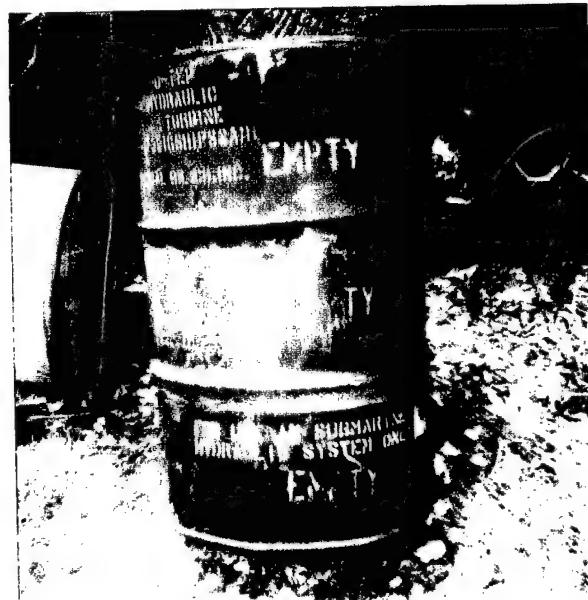
Photograph 5

CONDITION: Hazardous materials were found stored in many locations. While storage areas are designated as storage areas at Tully Lake, these other areas have not all been documented as legitimate storage areas. (Photo 3,4,5,6,7,8 & 22)

CONDITION: Not all hazardous waste containers were properly labeled or stored in designated area. (Photo 3,4, 5,6,7, & 8)

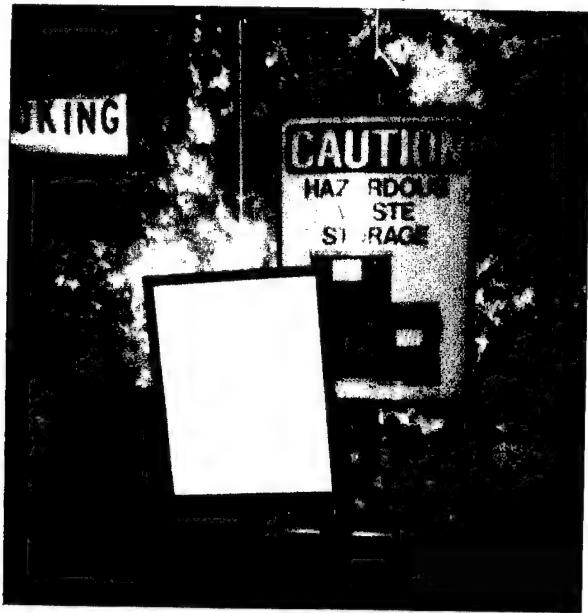
Photograph 7

CONDITION: A 55 gallon drum present in a materials storage area near the dam spillway appears to be full or partially full. Contents are unknown, but may be rainfall that has leaked into the drum over time (project manager believes that all drums were empty when brought to site). The drum is labeled as containing freon. (Photo 7,19, also Photo's 18,20, & 21)

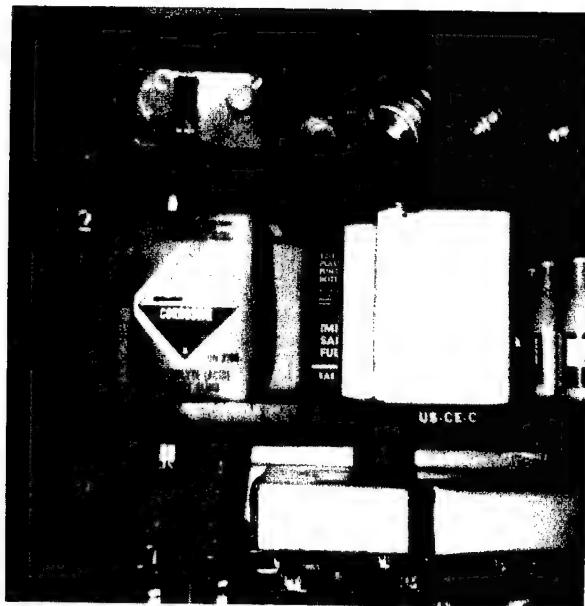
Photograph 10

CONDITION: In the past, the hazardous waste storage building was being utilized as a collection and storage point for hazardous waste products imported from other projects/facilities. Tully Lake is not properly permitted as a collection and storage facility for hazardous waste products. (Photo 10)

SOLUTION: In the future, operate the facility in accordance with the EPA license conditions

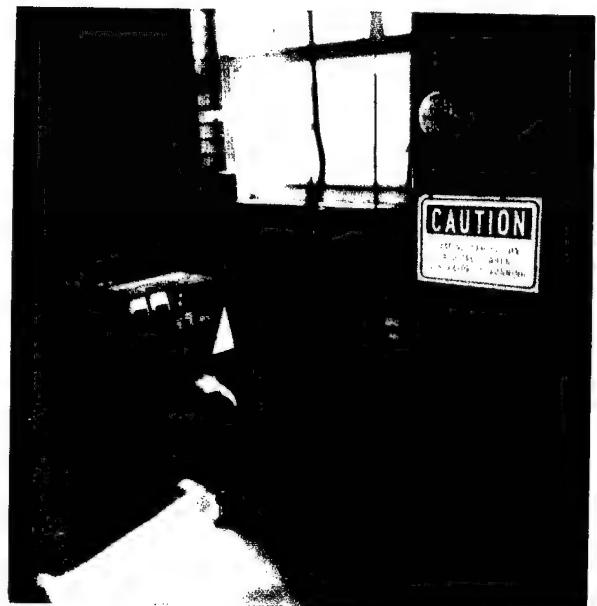
Photograph 14

CONDITION: Materials were found leaking in the storage area.  
Housekeeping of hazardous material storage containers was poor.  
29 CFR 1910.(e)(z), DoD 4145.19-R-1 (Photo 10,11,12,13 & 14)
